THE NAPERVILLE STREAMBANK RESTORATION

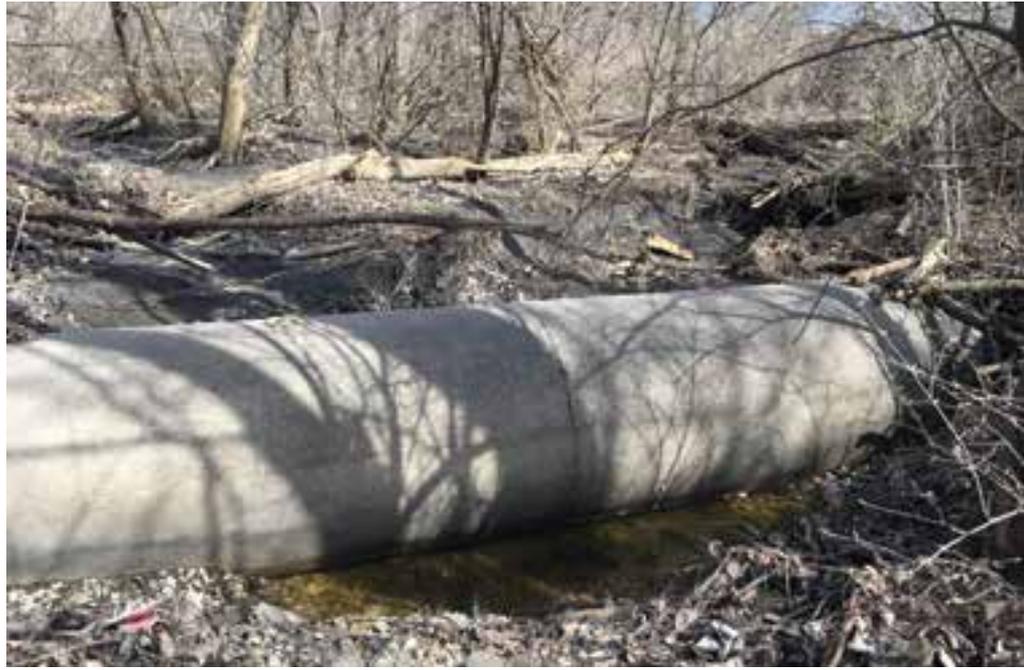
Exposed interceptor sewer pipe.

Field evaluation also identified where the sewer interceptor was exposed because of the loss of soil cover over the pipe caused by upland runoff and riverbank erosion. Some of the most significant exposure was at pipe dam locations, where upland inlets and sag

pipes were no longer in use, completely plugged up, or buried. Consequently, upland flow had no choice but to flow over the pipe, scouring away the earth until the pipe was acting as a dam.

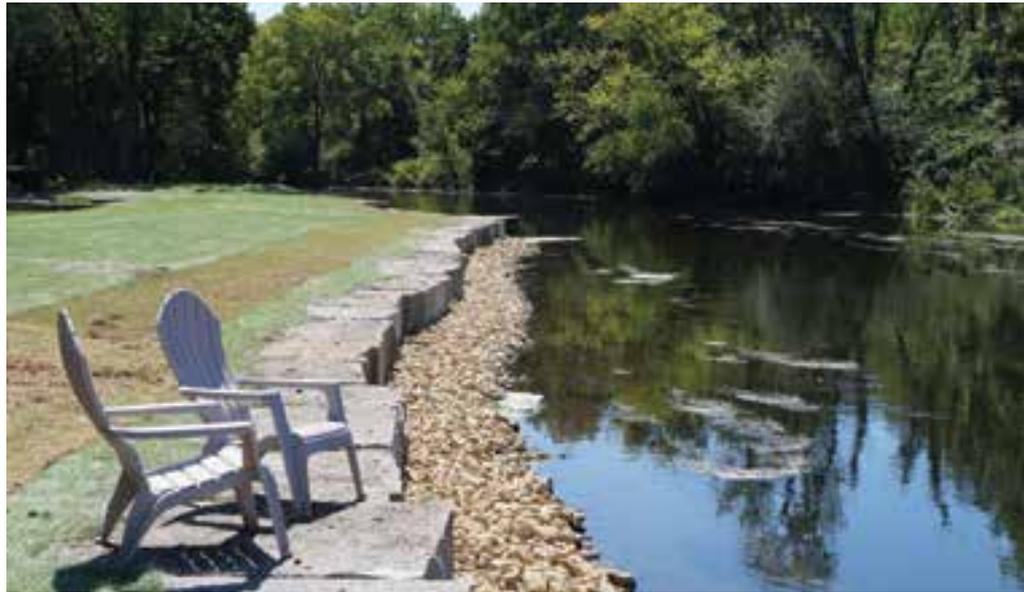
After construction of the ledge stone wall, residents were already enjoying their new backyard by placing chairs at the bank.

Many of the backyard locations featured turf grass where the shallow rooted system was not able to hold onto the soils and stabilize the riverbank from erosion, resulting in an average backyard loss of 12 feet, with some locations experiencing loss of up to 25 feet. Ledge stone walls were installed, enabling up to

4 feet of backyard to be restored. These walls consisted of large, heavy cut stone used to provide vertical stability while maintaining a natural aesthetic.

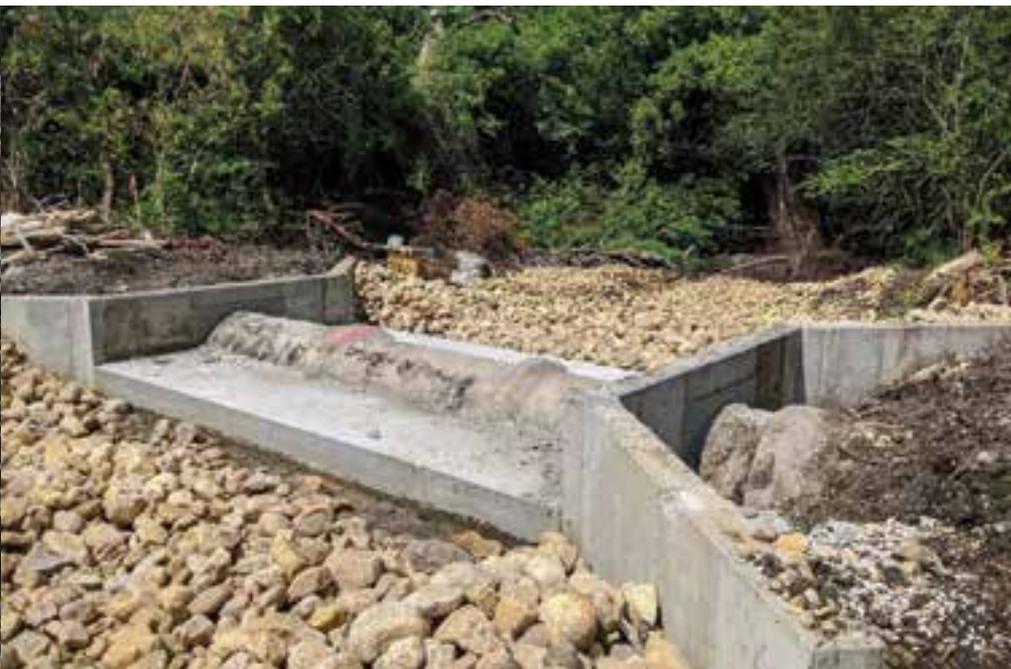
One of the pipe dam locations completed during construction in 2020.

One option to remedy this problem was to excavate underneath the pipe to create a pipe bridge, but the pipes were so close to the same elevation as normal river water levels that this would essentially just bring the river up into the

upland area. It was decided to leave the pipes where they were and stabilize them in place by creating a pipe cradle that would allow the runoff to continue to flow over the pipe while maintaining current flow conditions and not backing up the flow upstream or impacting the wetland area created by the pipe dam.

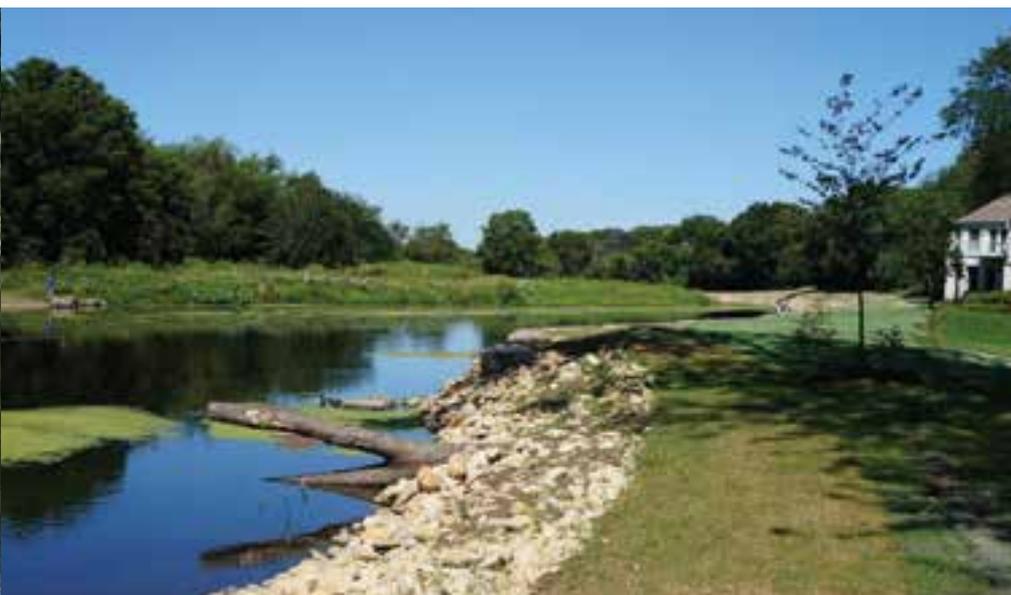
A tree repurposed as fish habitat.

Along the riverbank, trees were removed because vegetation was not able to grow underneath the tree canopy, causing further erosion along the riverbank. Some trees were repurposed as fish habitat.
